WL-TR-95-4108

**HIGH TEMPERATURES COATINGS
FOR TITANIUM ALUMINIDES**

**J. C. Schaeffer
R. L. McCarron**

**GENERAL ELECTRIC COMPANY - AIRCRAFT ENGINES
ENGINEERING MATERIALS TECHNOLOGY LABORATORIES
CINCINNATI, OHIO 45215-6301**

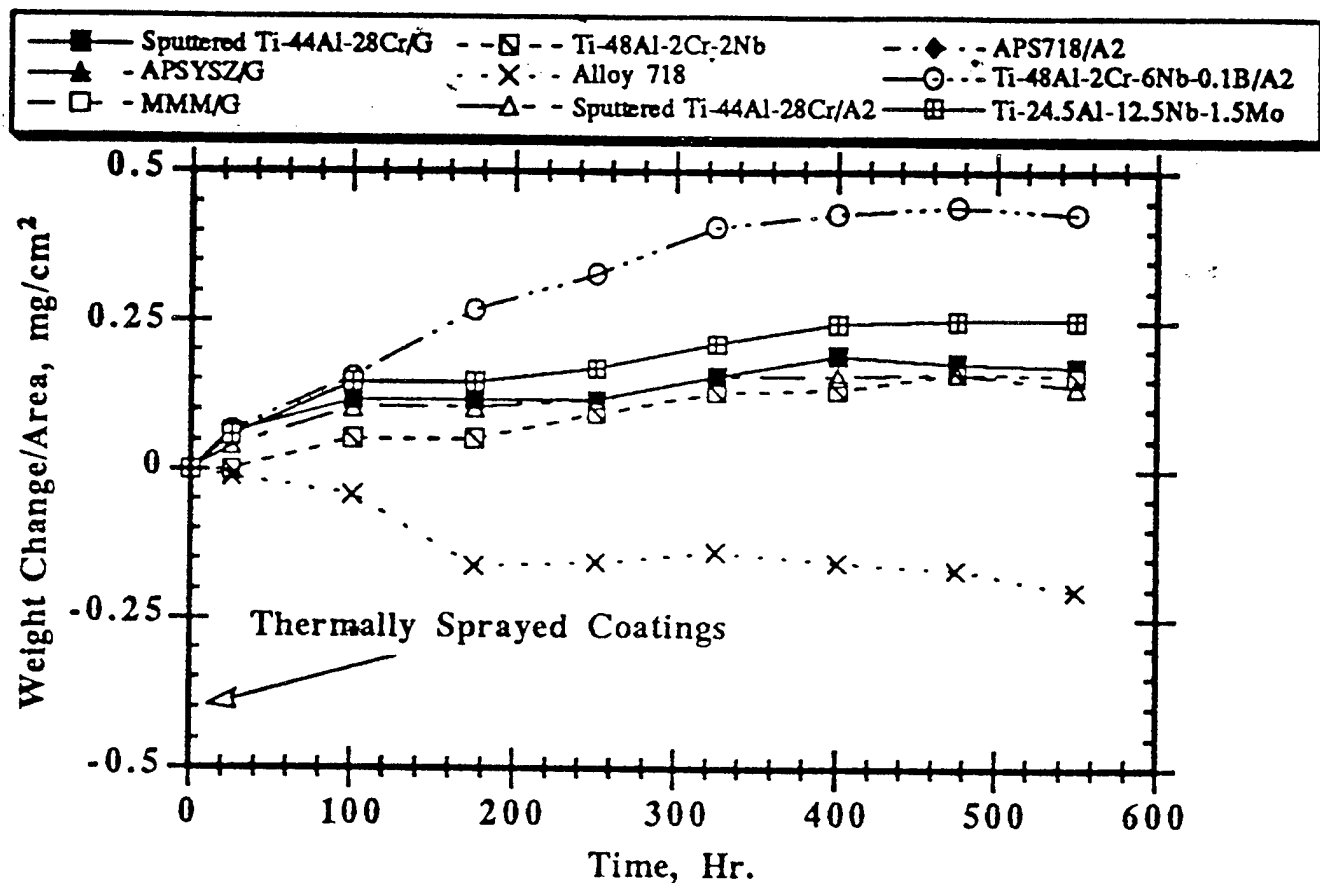
Figure 88. Weight change/area data for unrinsed coated and uncoated Ti-aluminides during the high pressure compressor burner rig test. The y-axis has been enlarged to differentiate the behavior of systems that showed little weight change.

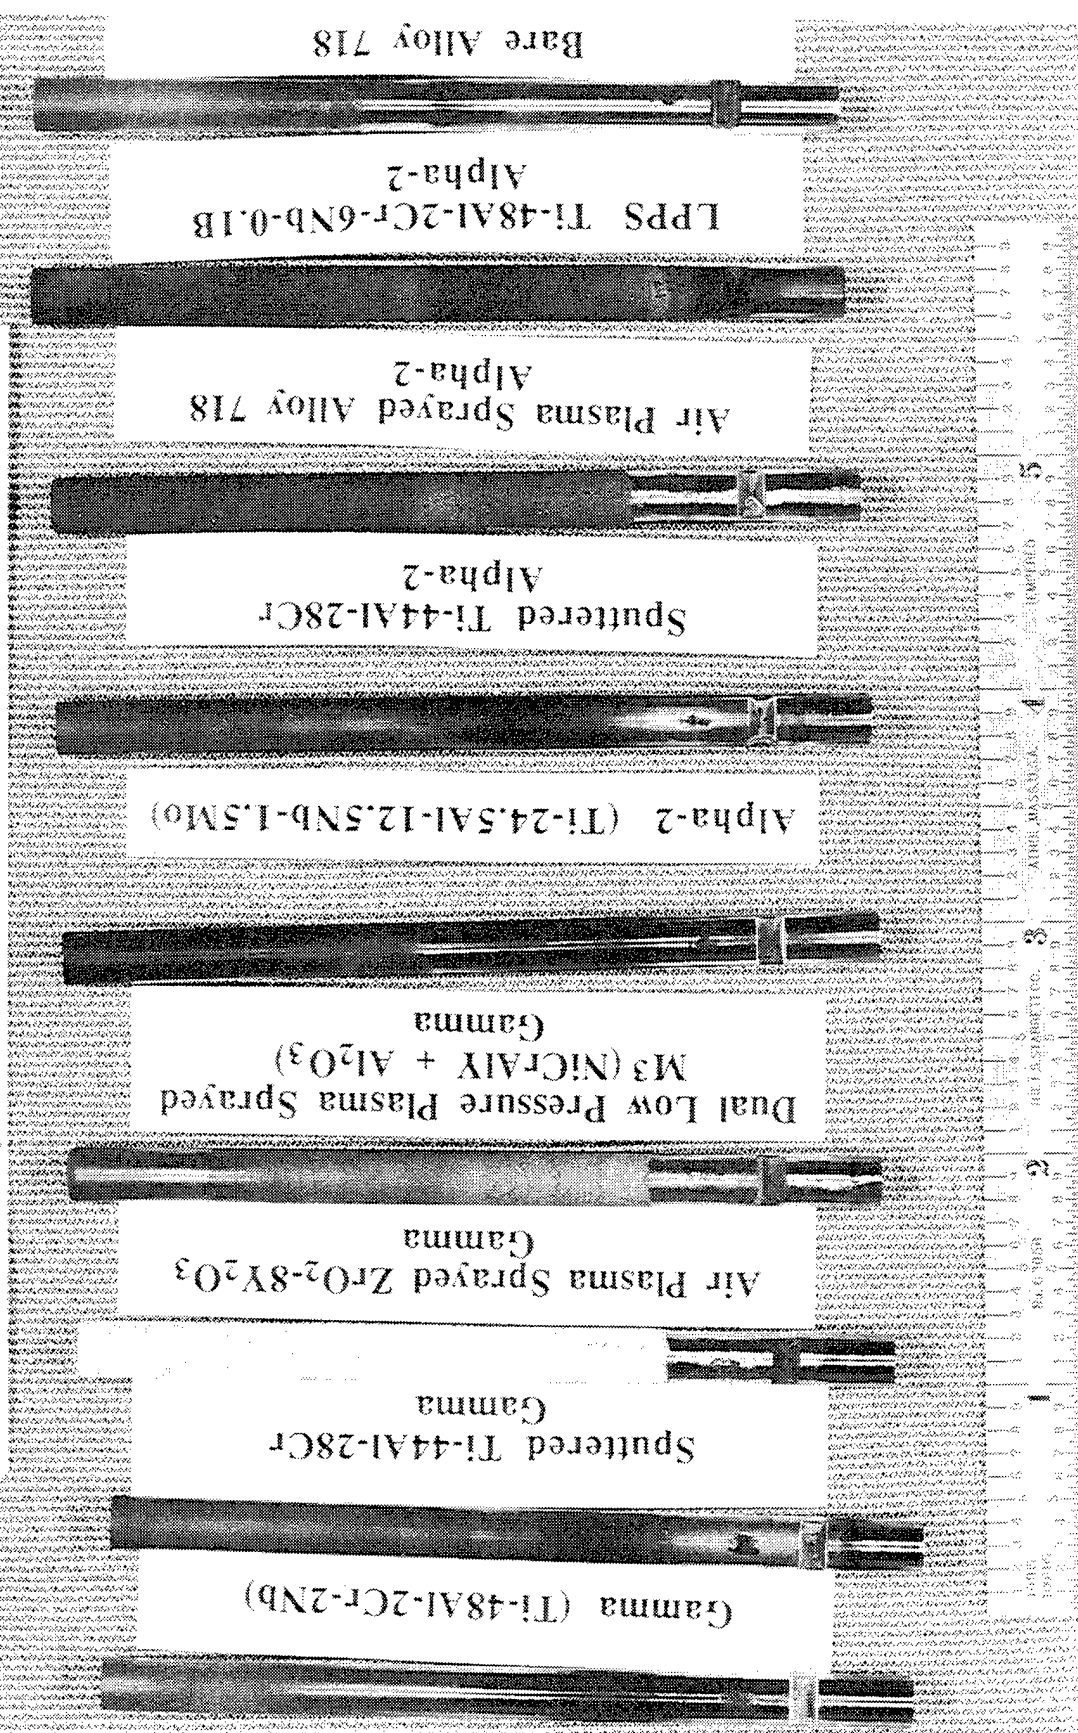
Figure 89. Color photograph shows the coated and uncoated Ti-aluminide samples after 3200cycles or 550Hr under high pressure compressor (CHC/O) environmental conditions. The notched side faced the combustor.

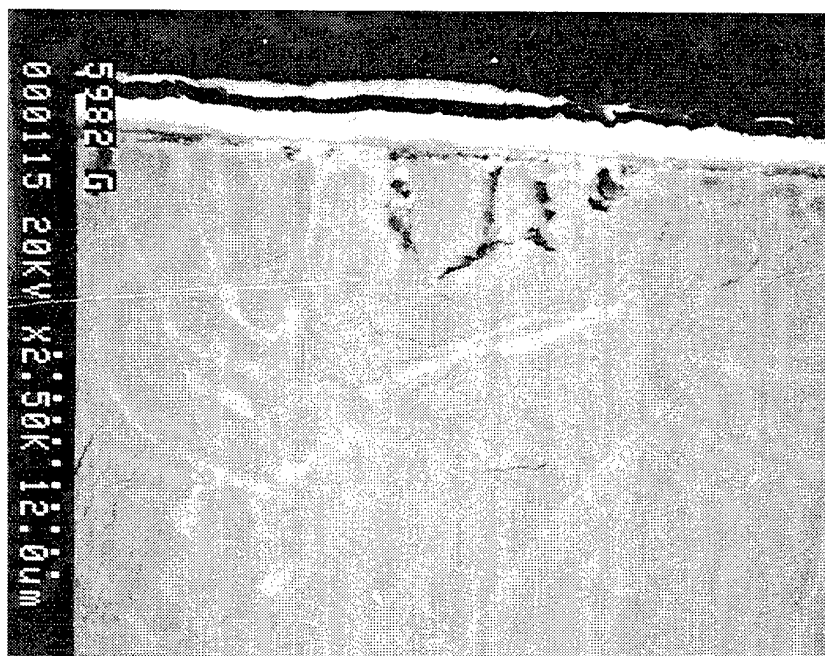
Figure 91. Cross sectional micrographs taken from the hot spot of the uncoated gamma alloy after the HPC environmental test.

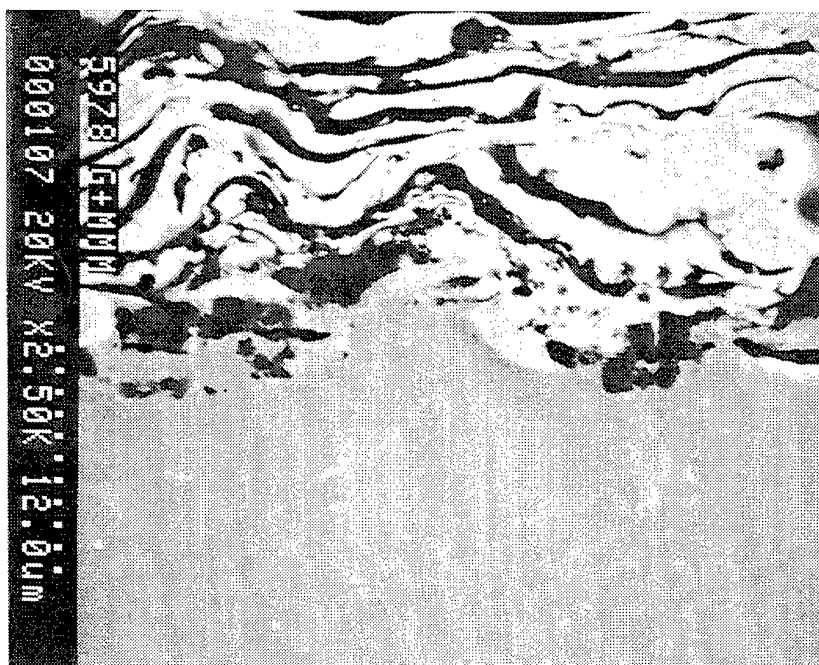
Figure 93. Cross sectional micrographs taken from the hot spot of the cermet (50%NiCrAlY +alumina) coating on the gamma alloy after the HPC environmental test. The coating shows no cracking, spalling or signs of degradation.

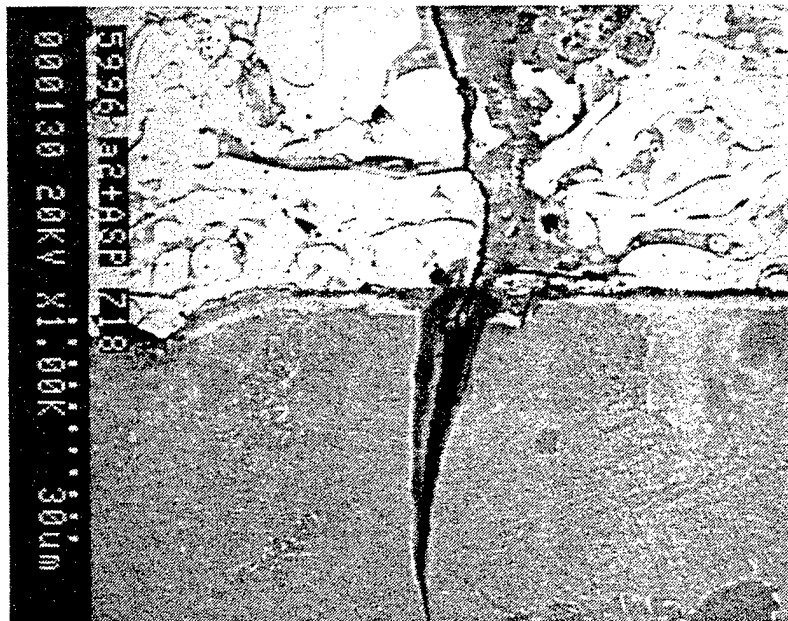
Figure 98. Micrographs of the cross section of the APS Alloy 718 coating on alpha-2 after the HPC environmental test.

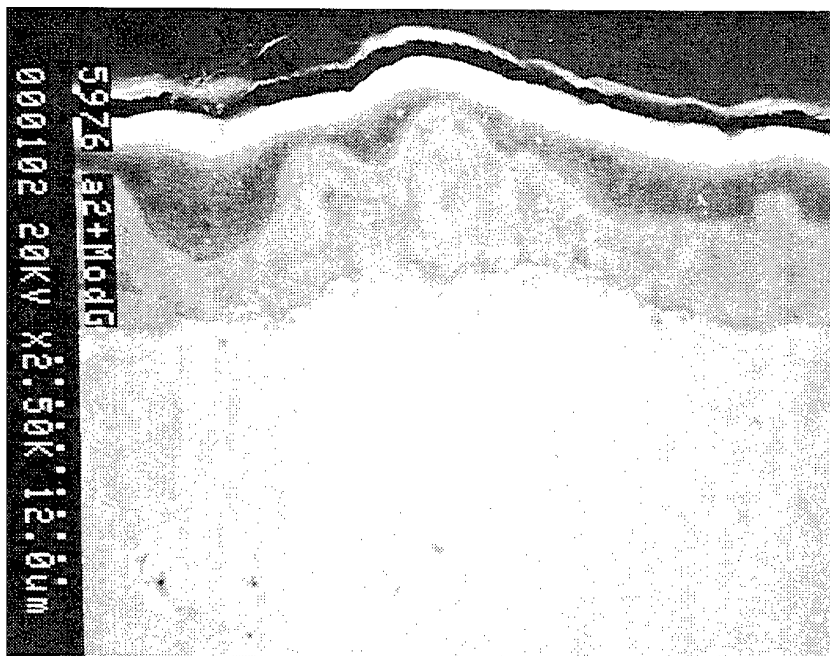
Figure 99. Micrographs of the cross section of the LPPS modified gamma coating on alpha-2 after the HPC environmental test. No thermal fatigue cracks were seen on the coating.

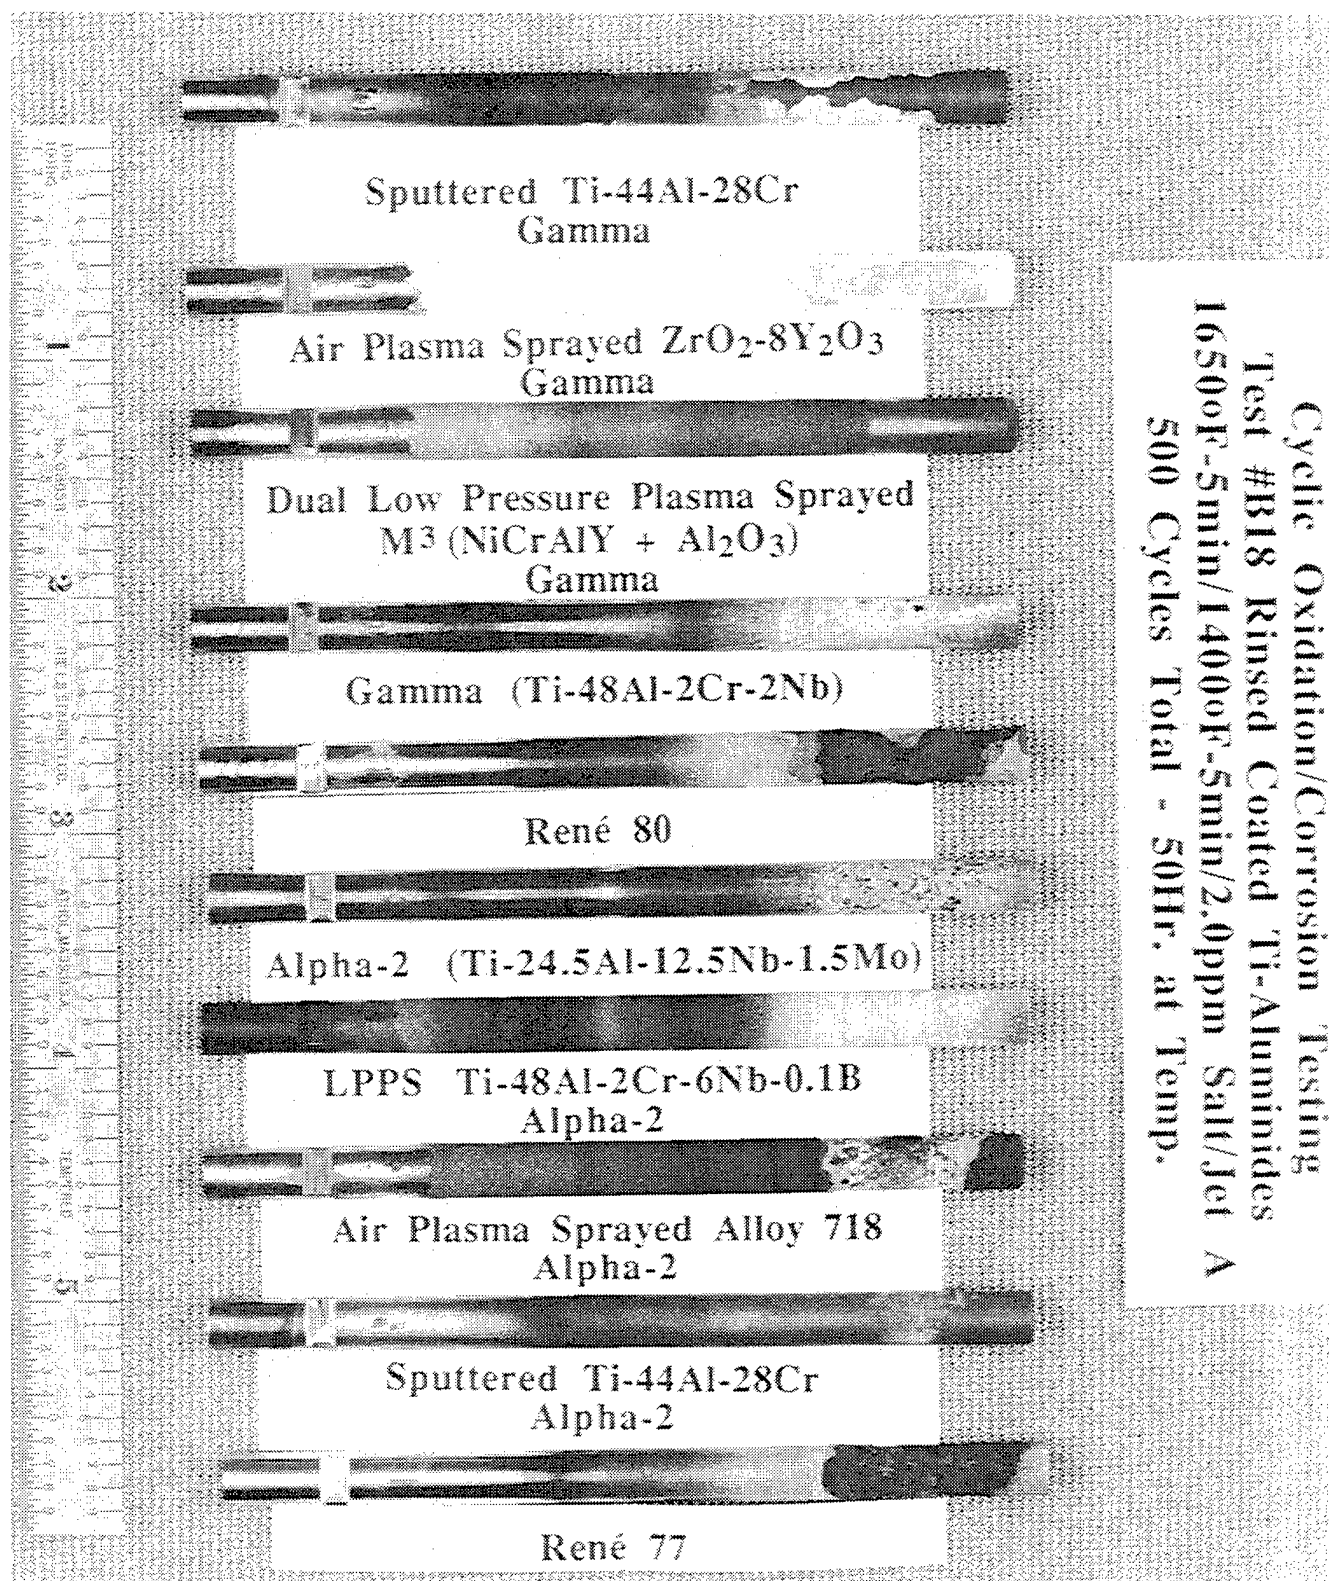
Figure 101. Color photograph shows the coated and uncoated Ti-aluminide samples after 498cycles or 50Hr under low pressure turbine (CHC/O) environmental conditions. The notched side faced the combustor. Note M^3 is the cermet coating.

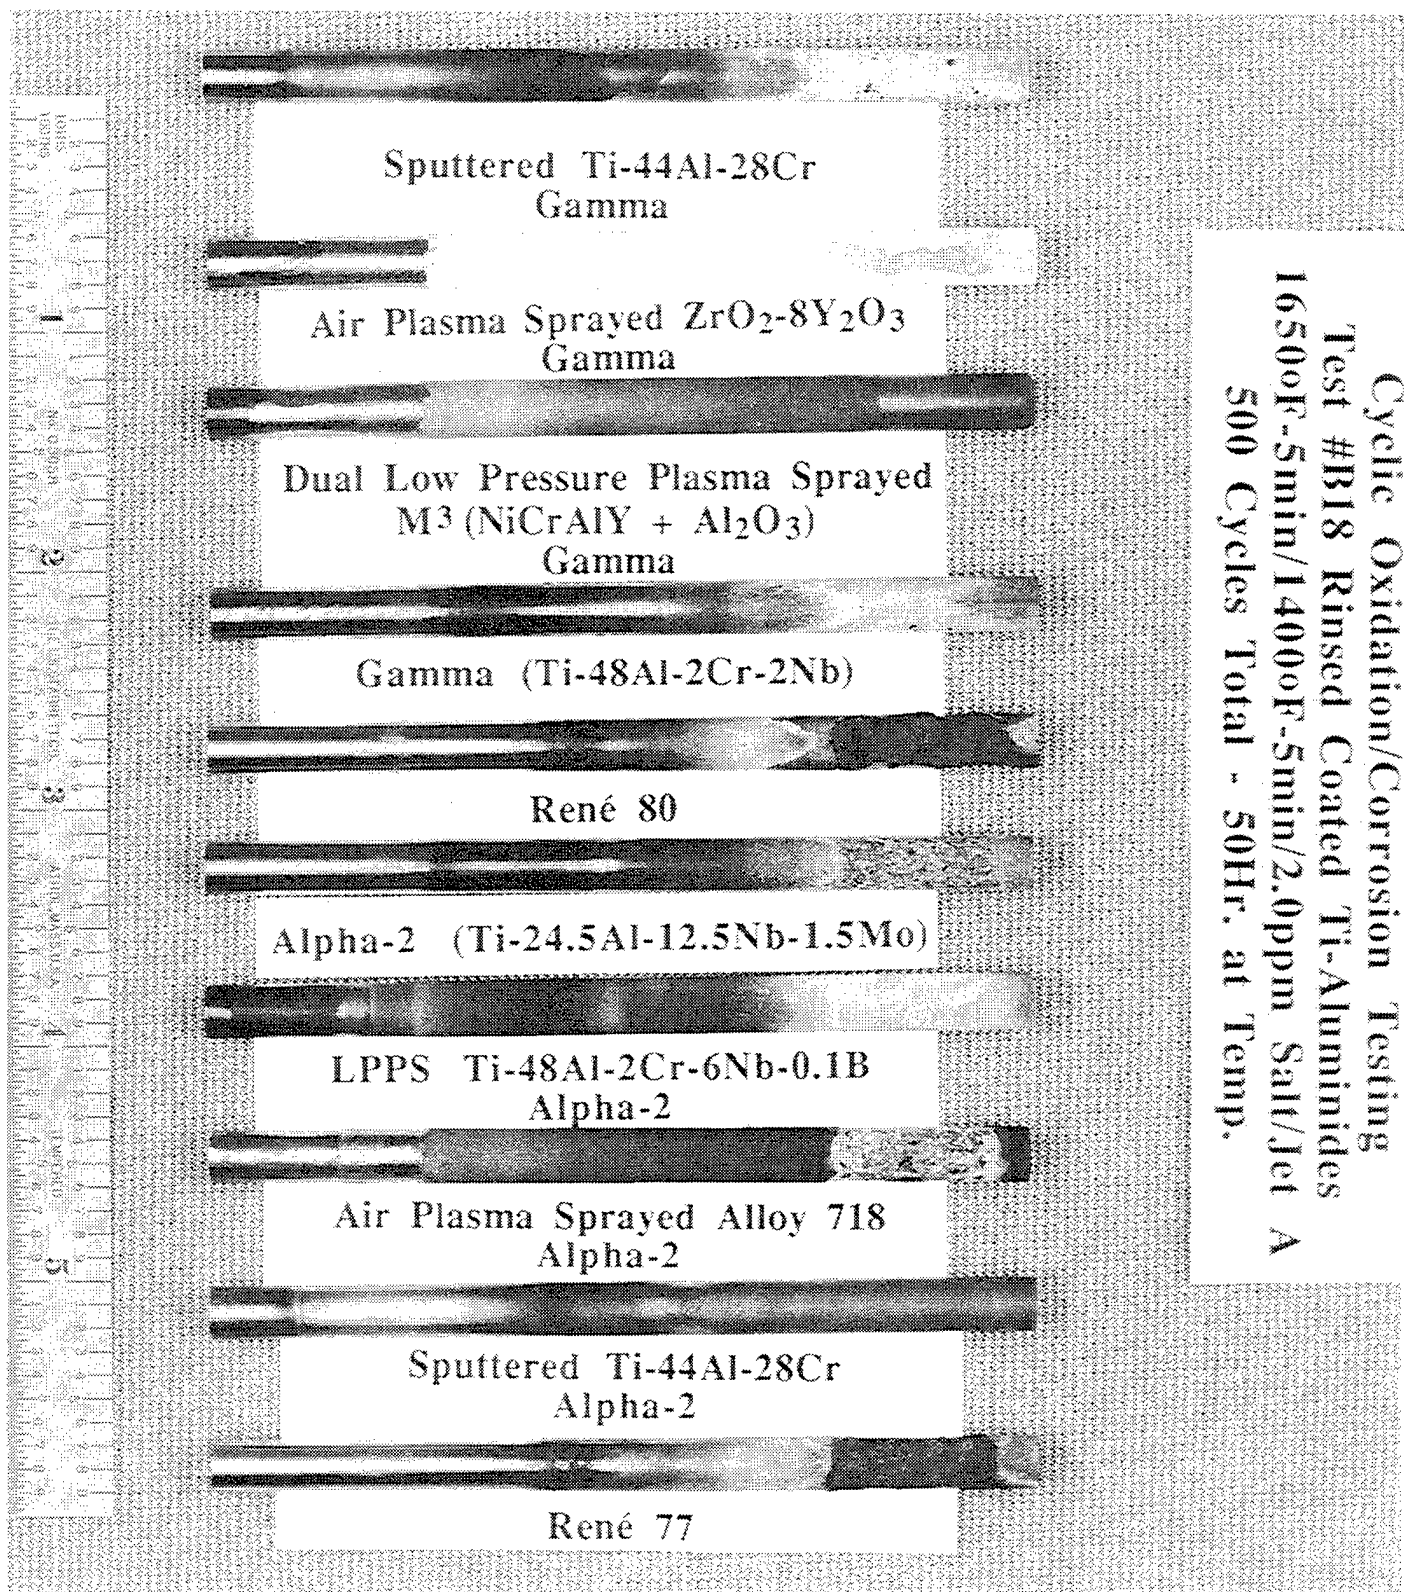
Figure 102. Color photograph shows the coated and uncoated Ti-aluminide samples after 498cycles or 50Hr under low pressure turbine (CHC/O) environmental conditions. This side of the pin faced away from the combustor. Note M^3 is the cermet coating.

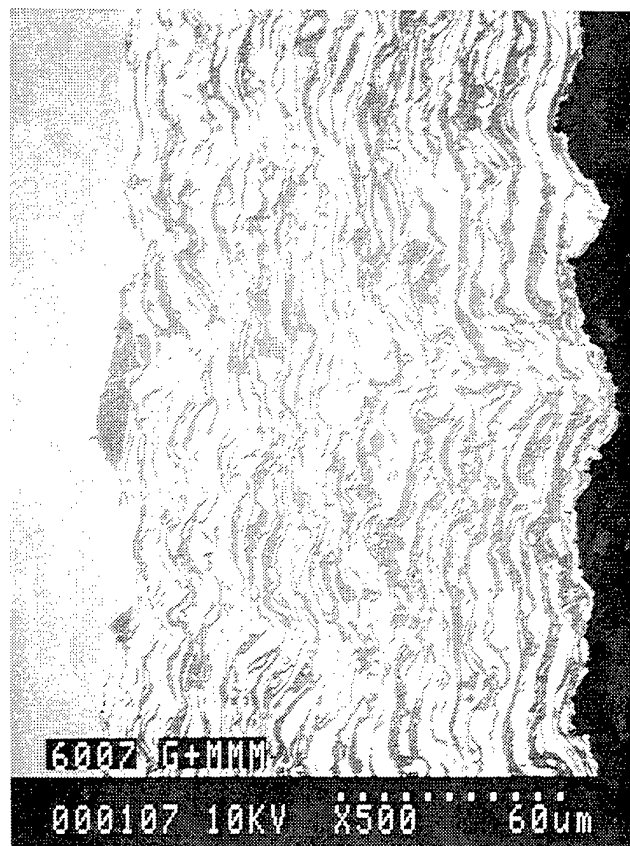
Figure 105. Cross sectional micrographs taken from the hot spot (top) and the 3.3cm sections (bottom) of the cermet (M³) coating on the gamma alloy after the LPT environmental test. No significant degradation was observed.

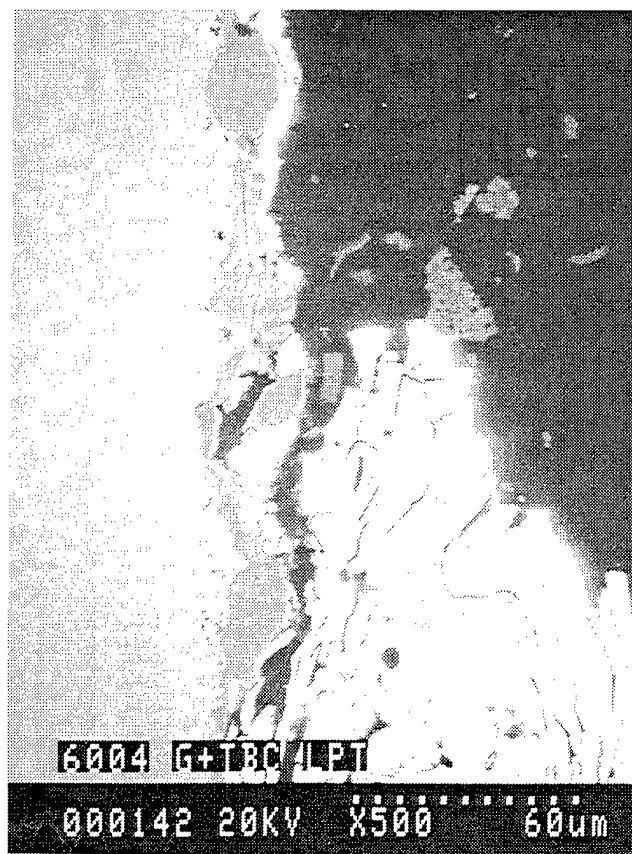
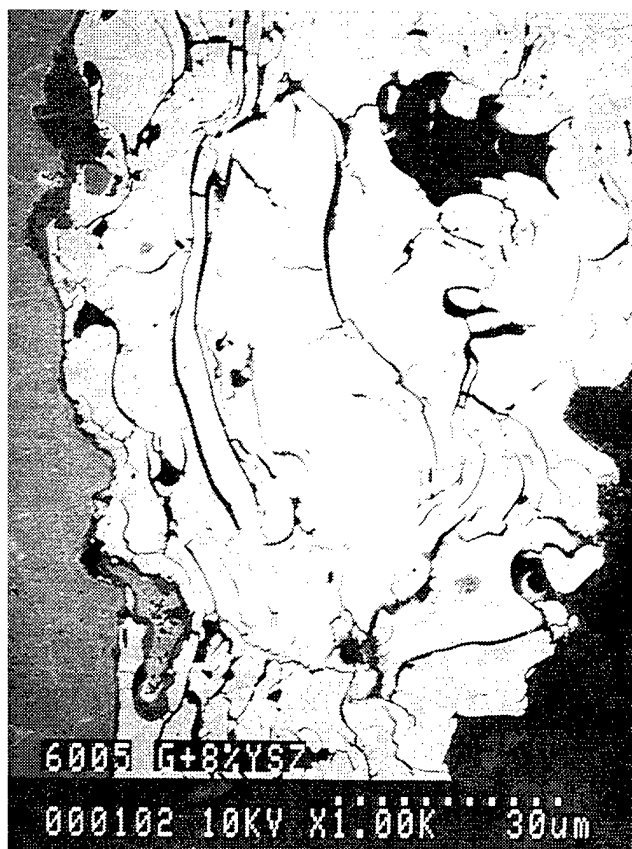
Figure 106. Cross sectional micrographs taken from the hot spot (top) and the 3.3cm sections (bottom) of the APS YSZ coating on the gamma alloy after the LPT environmental test. The coating spalled during the test.

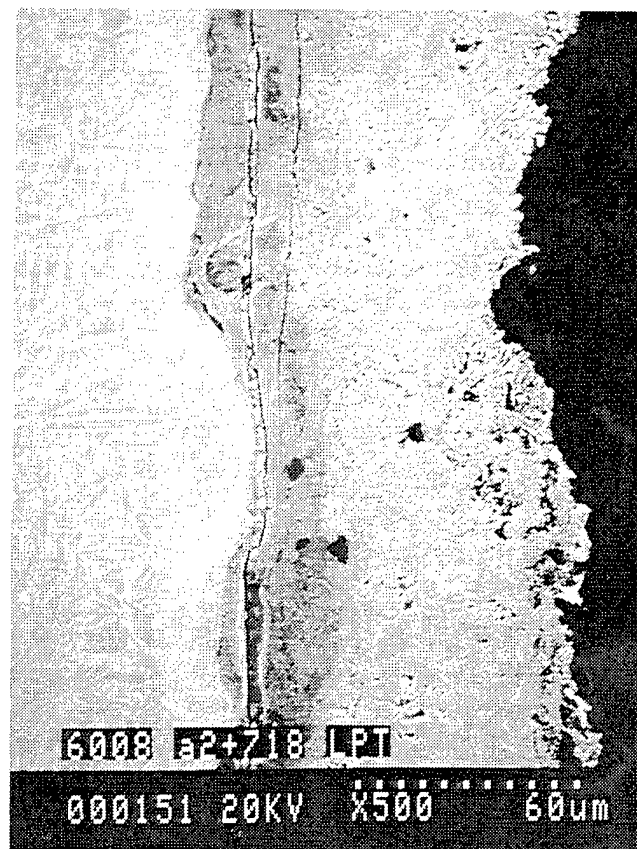
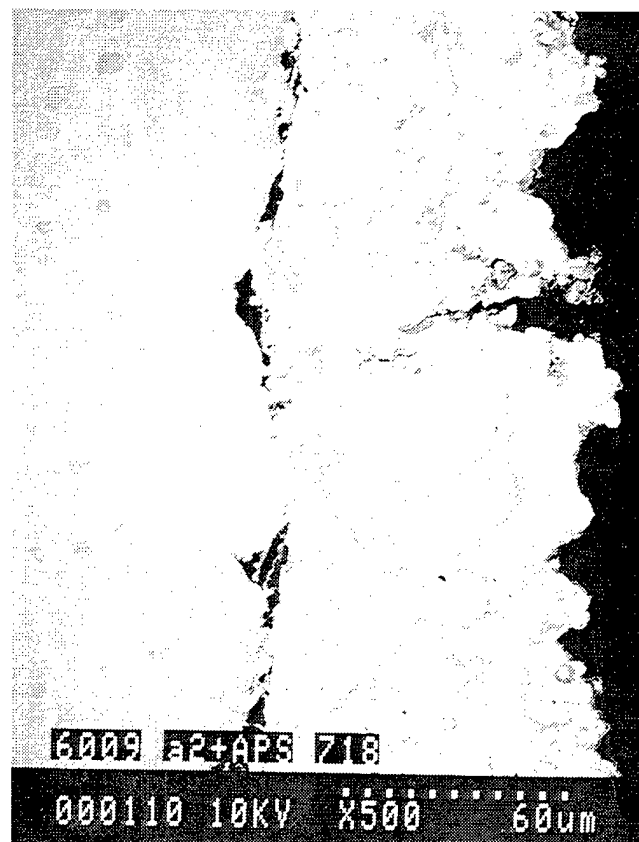
Figure 109. Cross sectional micrographs taken from the hot spot (top) and the 3.3cm sections (bottom) of the APS Alloy 718 coating on the alpha-2 alloy after the LPT environmental test.

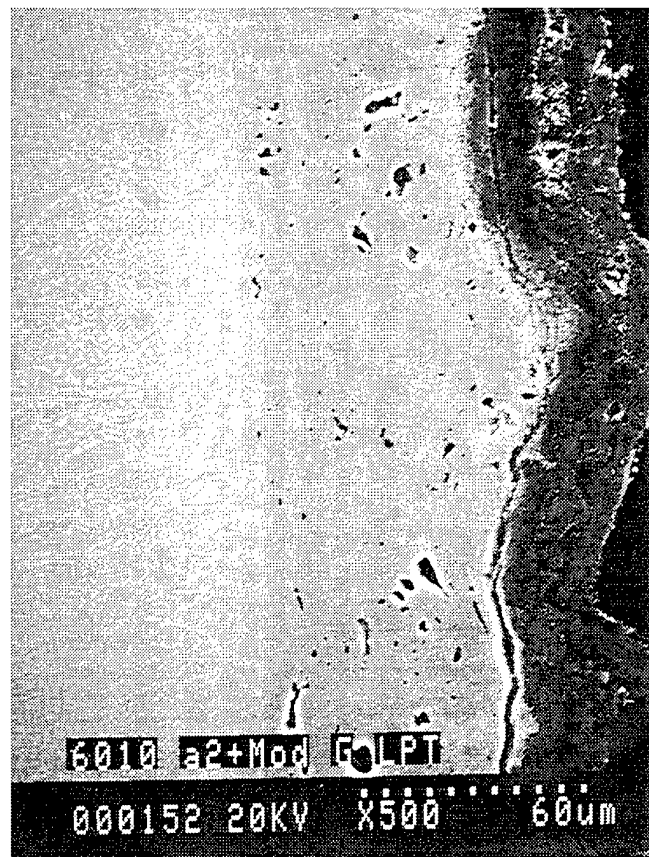
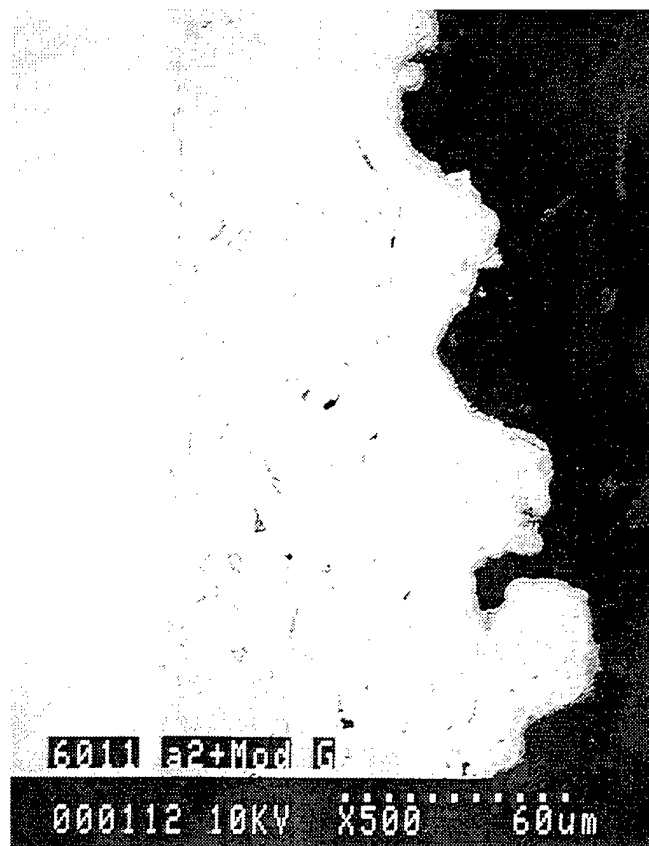
Figure 110. Cross sectional micrographs taken from the hot spot (top) and the 3.3cm sections (bottom) of the LPPS modified gamma coating on the alpha-2 alloy after the LPT environmental test.

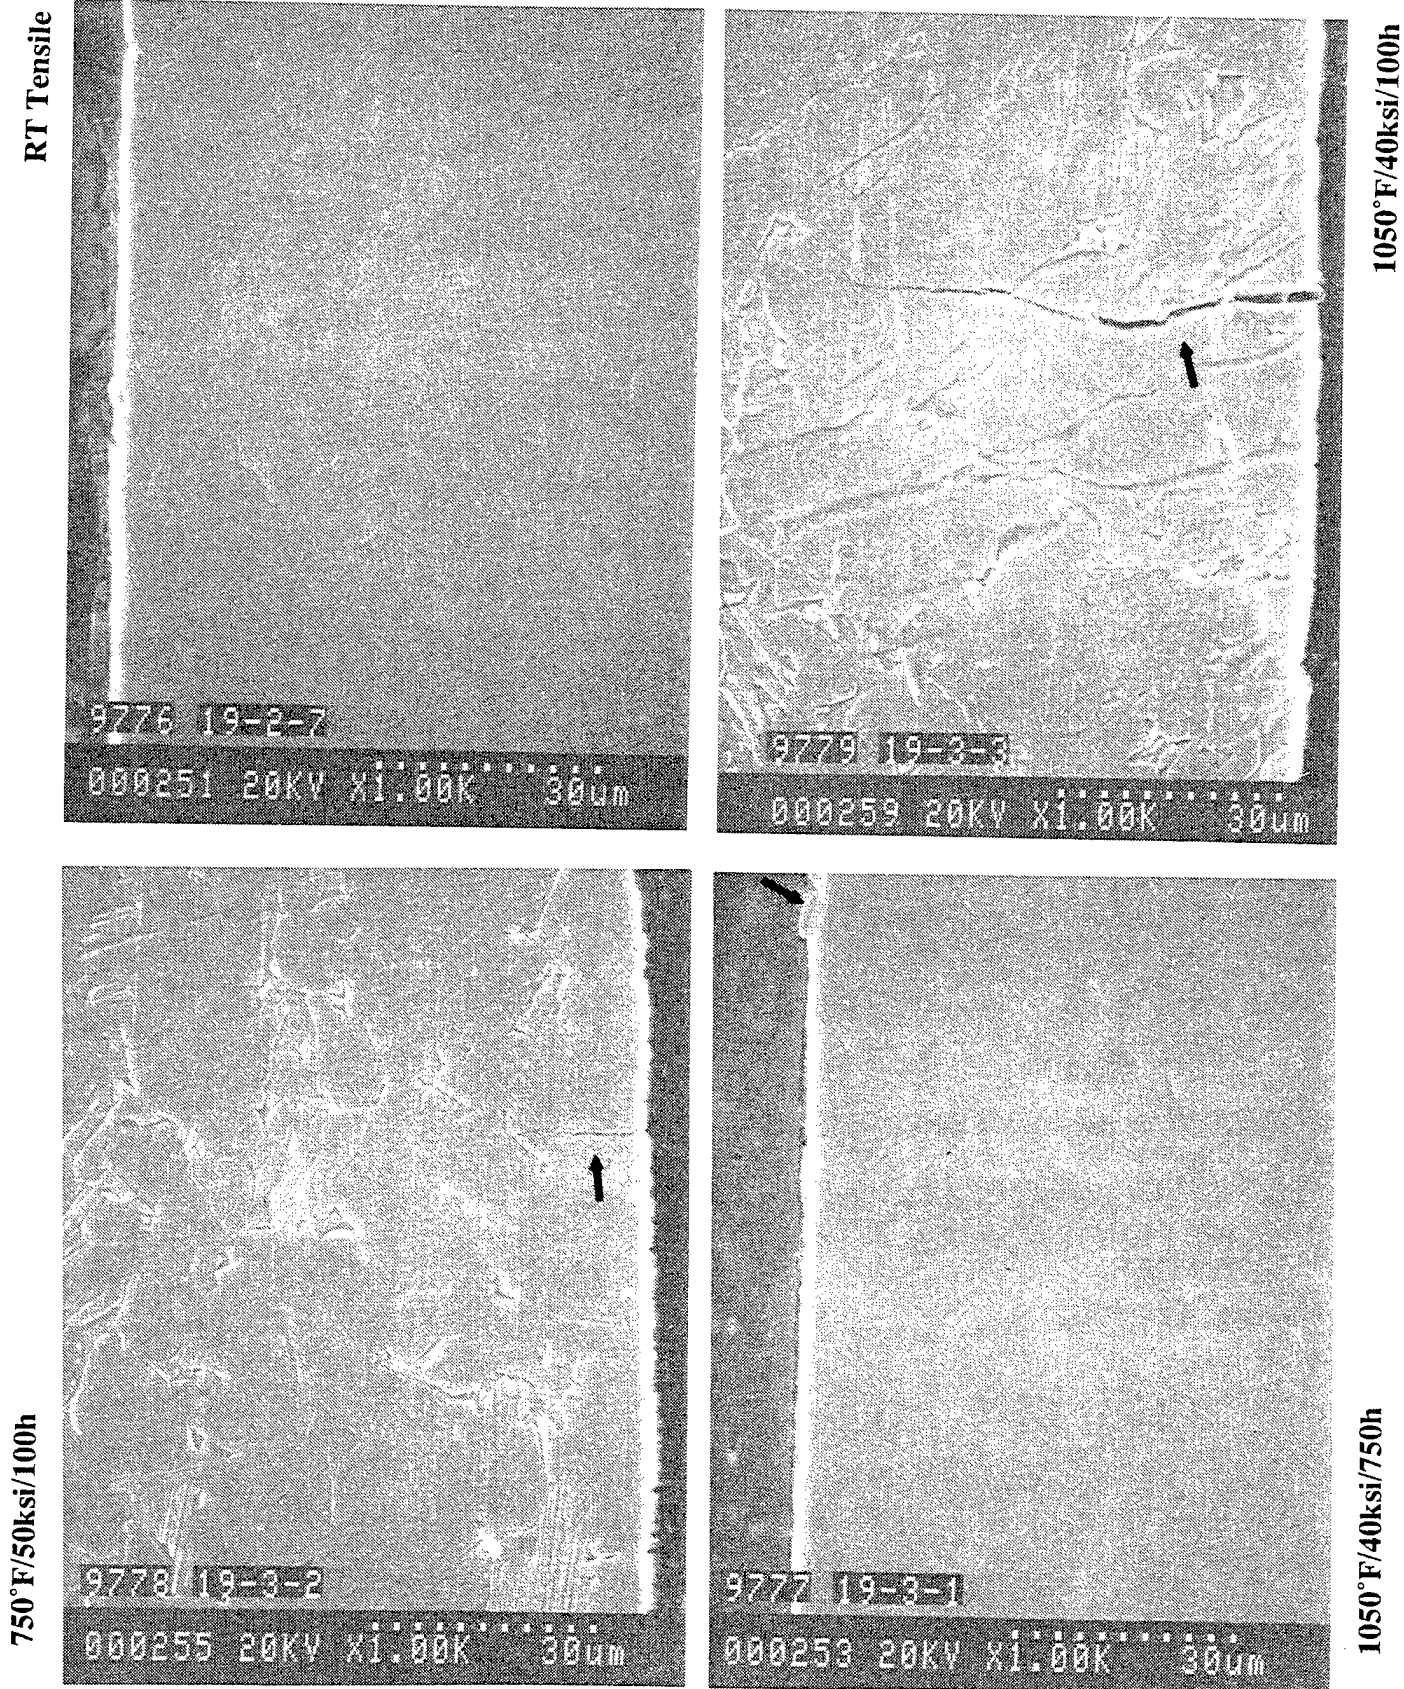
Figure 113. Higher magnification cross sections of uncoated gamma (Ti-48Al-2Cr-2Nb) specimens showing the a very thin external scale.

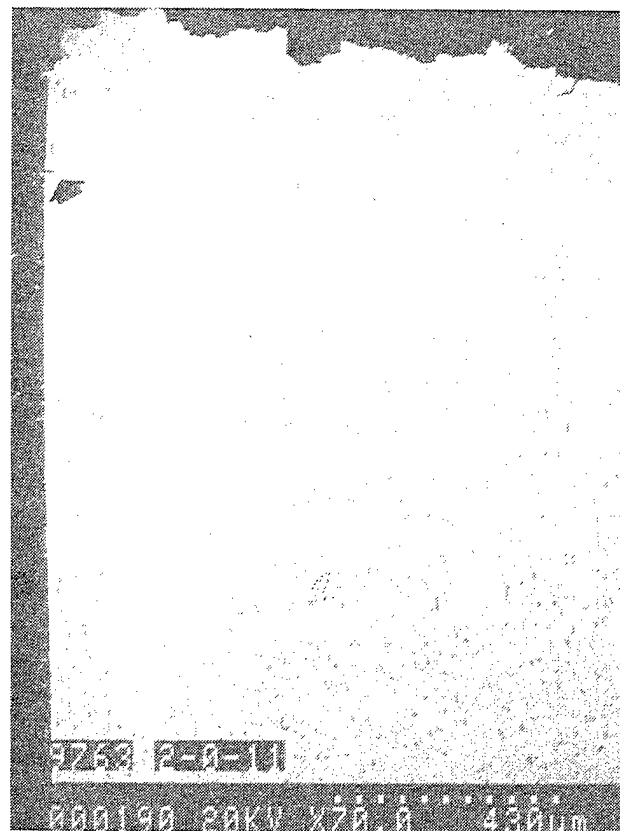
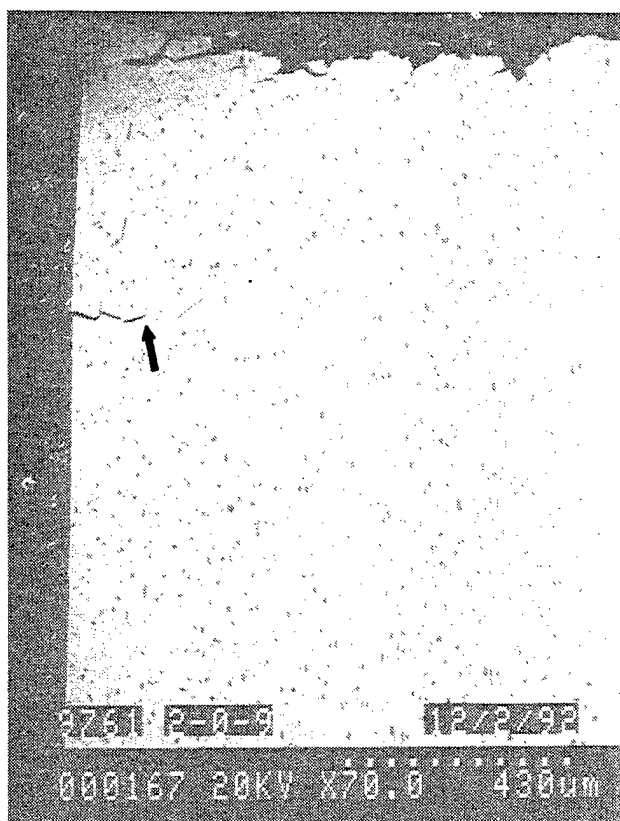
Figure 121. Low magnification cross sections of uncoated alpha-2 (Ti-24.5Al-12.5Nb-1.5Mo) specimens showing the fracture path and secondary tensile cracking after various exposures.

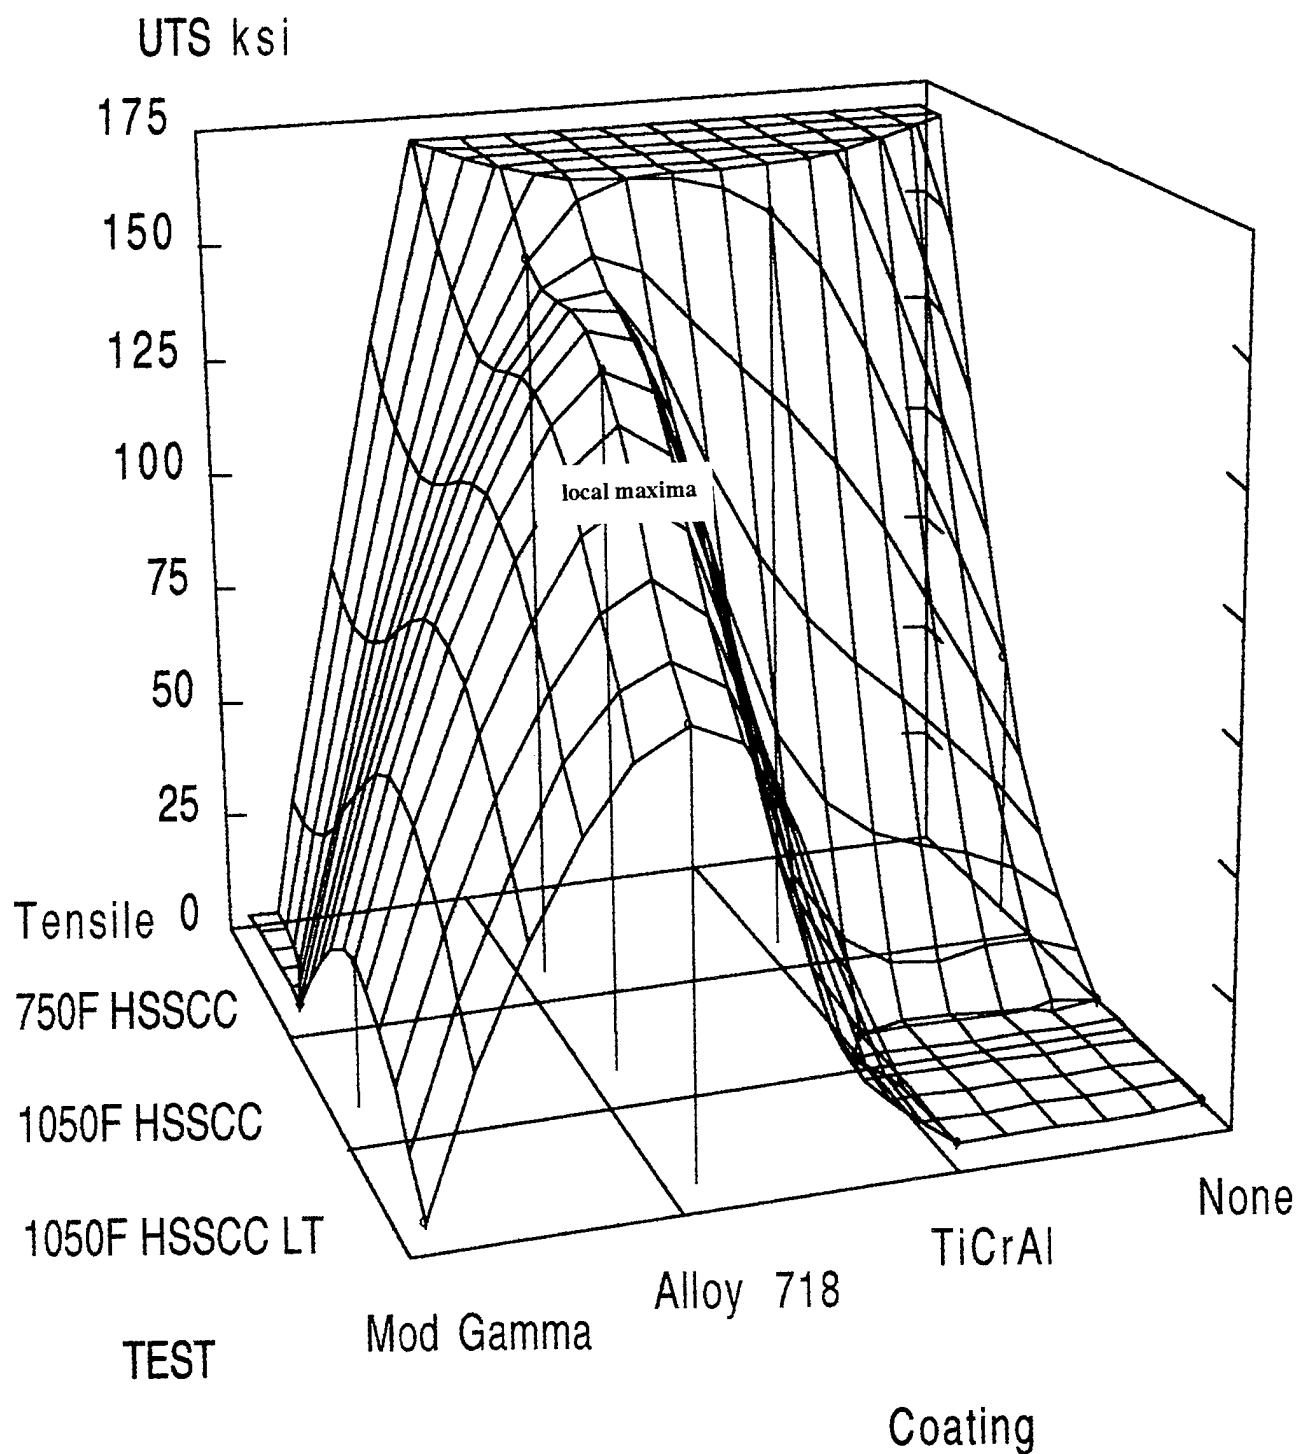
Figure 126. Plot showing the potency of the air plasma sprayed Alloy 718 as a coating for HSSCC resistance. The Alloy 718 coating achieves a local maxima on the UTS response surface of coating vs. test. "LT" means long time exposure.

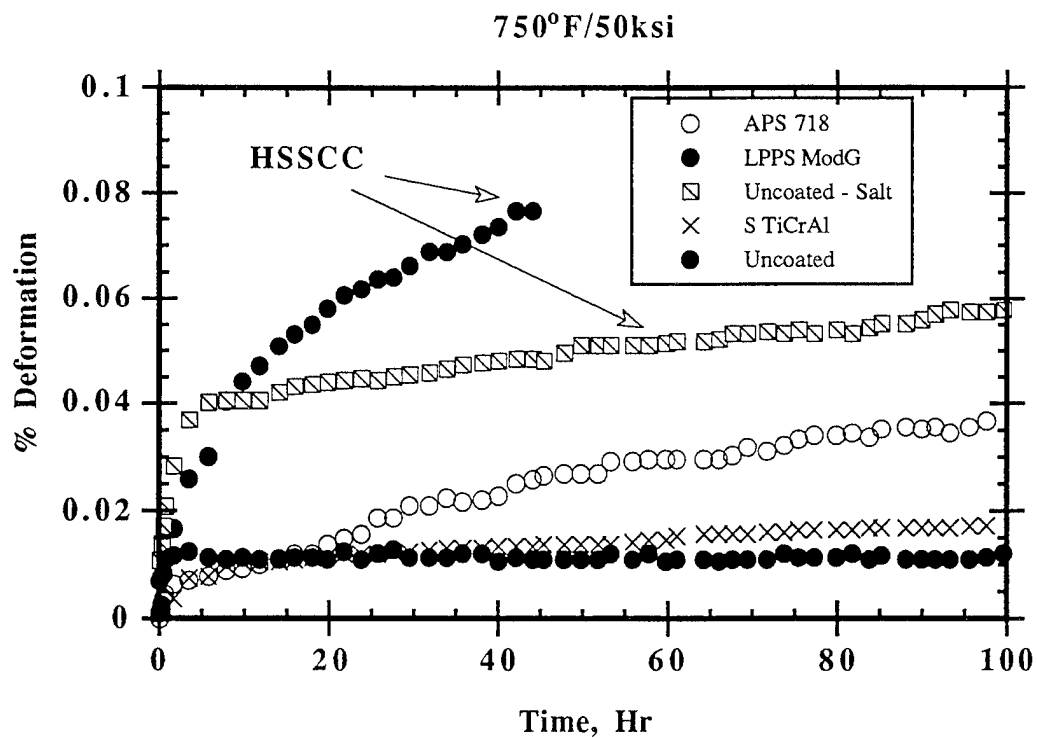
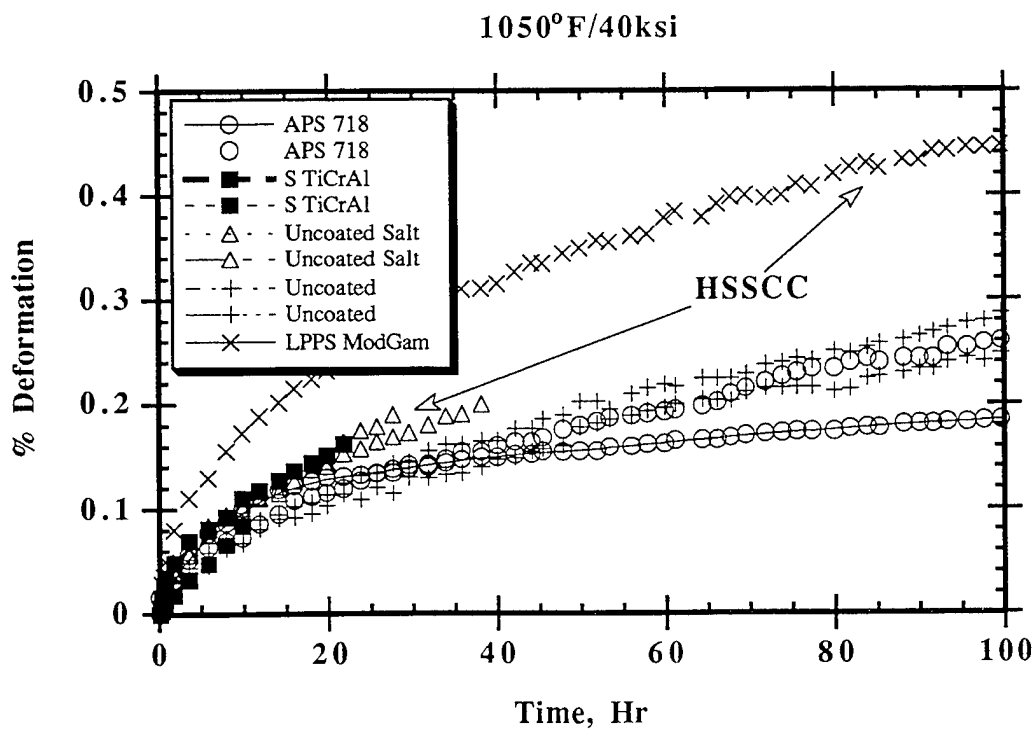
Figure 130. Creep curves for 100h exposures at 750°F/50ksi and 1050°F/40ksi of coated and uncoated alpha-2 showing greater deformation for samples undergoing HSSCC damage.

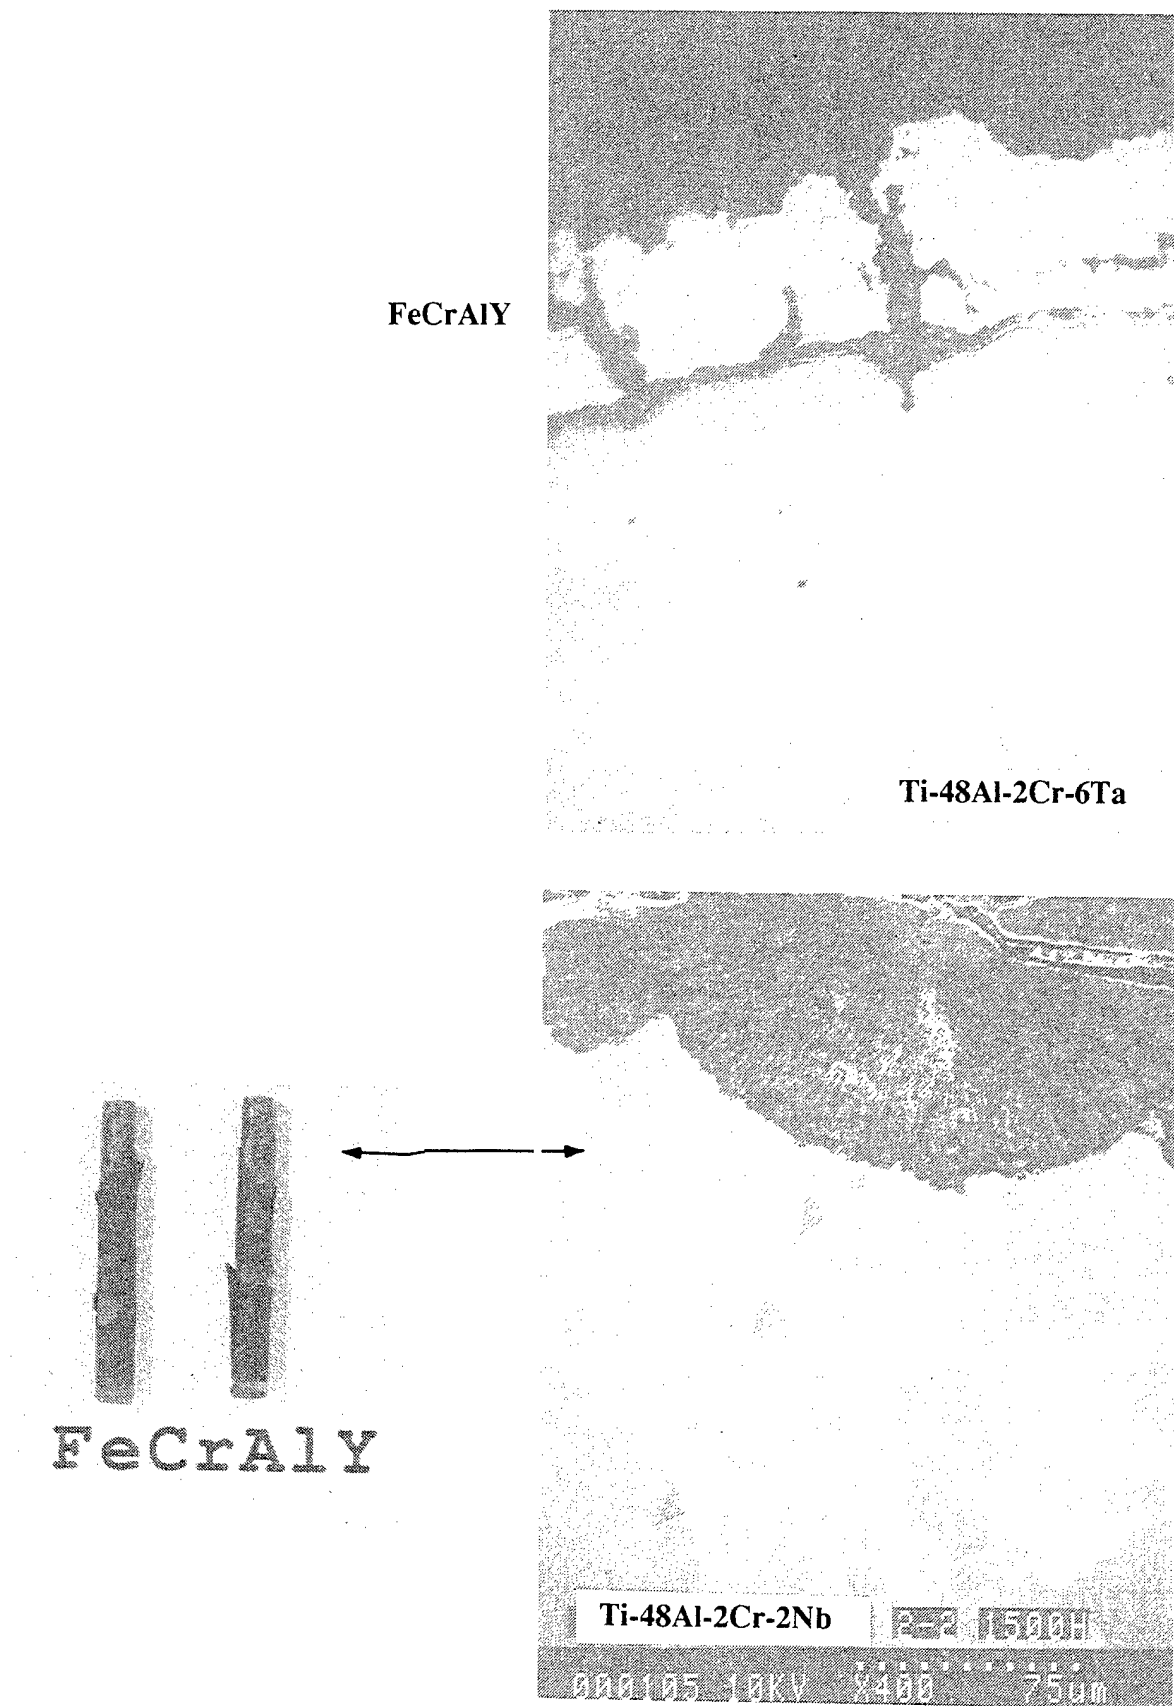
Figure 131. Micrographs of low pressure plasma sprayed FeCrAlY on cast and forged gamma alloys after 1500Hr of cyclic oxidation at 900°C (1652°F). Thermal fatigue cracks and coating spallation were observed.
